IBM FlashSystem 840

Firmware Version 1.2.1.10

Release Notes

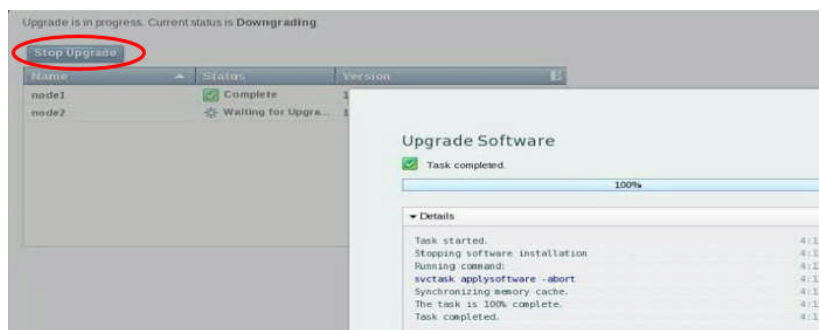
If the upgrade takes more than two hours to complete, it may have stalled. Upgrade status is viewed by issuing `lsupdate` CLI command or by going to Settings → System → Update System in the GUI. Both show a “Stalled” status. In most cases, this can be resolved by aborting the upgrade and reattempting the upgrade after the system downgrades to its original level. To abort the upgrade, issue the `applysoftware -abort` CLI command or click the “Stop Upgrade” button in the GUI, as seen in Figure 1 below.

Figure 3. Aborting the upgrade
